4 Point Insurance Report

Photos For: Dick & Jane Sample-09/03/23

Property Address: 1234 Memory Lane Paradise, FL 32503

4-Point Inspection Form

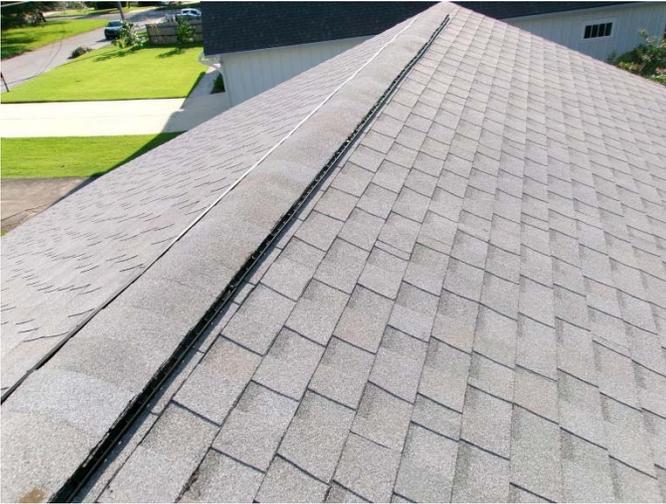
Roof View – Photo 1

Covering material: C. SHINGLE
 Roof age (years): 1 YR
 Remaining useful life (years): 30 YRS
 Date of last roofing permit: 09/2022
 Date of last update: 09/2022

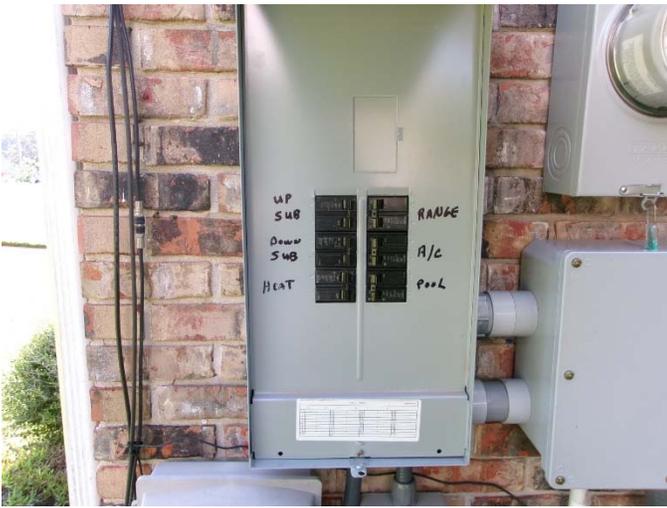
Panel age: 6 MONTHS
 Year last updated: 2023
 Brand/Model: GE

GE - 200 Amp Panel Front Cover

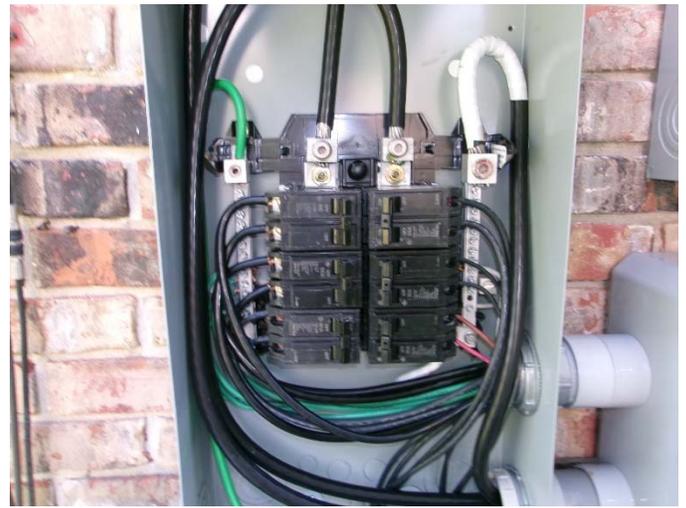
GE Service Panel – Circuit Breakers

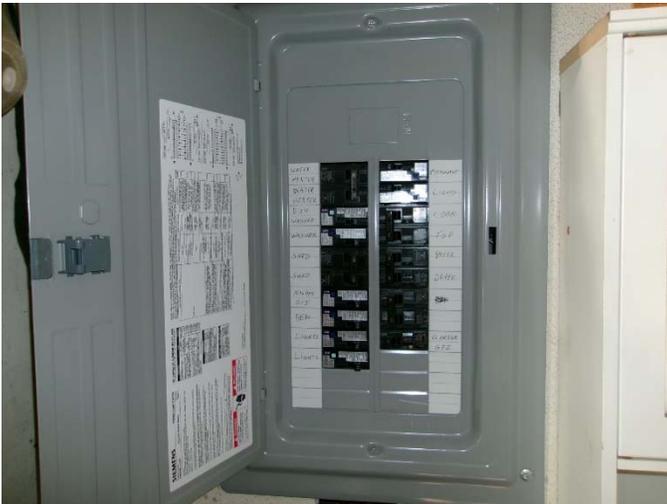
Panel age: 1YR
 Year last updated: 2022
 Brand/Model: SIEMENS

Siemens Subpanel – Front Cover

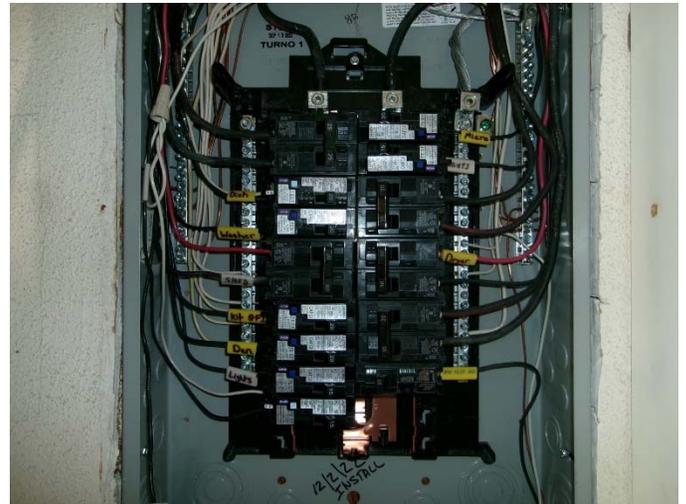
Siemens Subpanel – Copper Branch Wiring

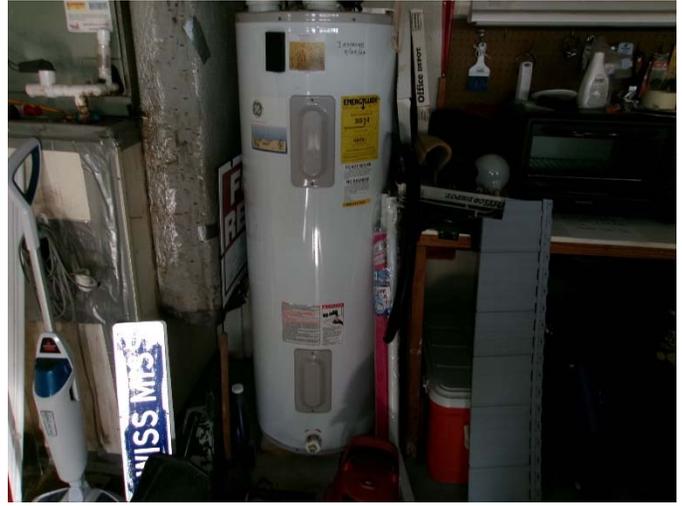
Water heater location: GARAGE - ELEC - 2009

Partially re-piped POX - AT THE WATER HEATER

Electric Water Heater - 2009

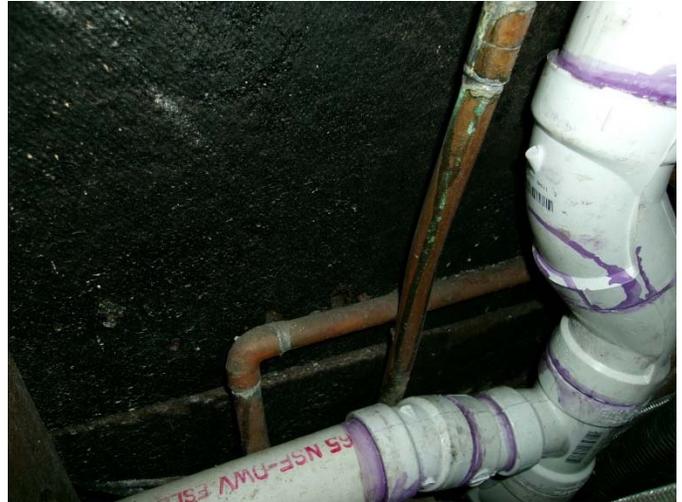
Original to home - Copper

Copper Piping
